G503 WWII Jeep Replacing Brake Light Switch

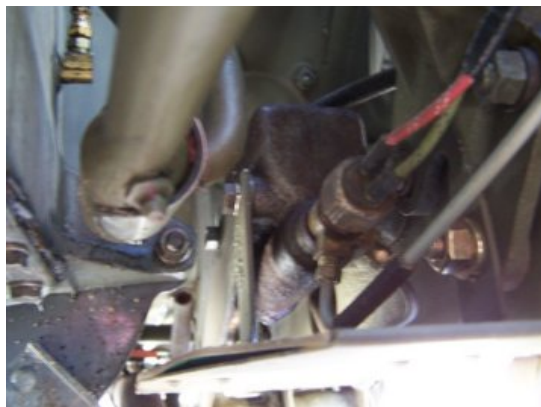
A common problem when your G503 WWII Jeep Brake Light no longer works is that the switch on the Master Cylinder has gone bad. It is not expensive or difficult to replace, here are the steps

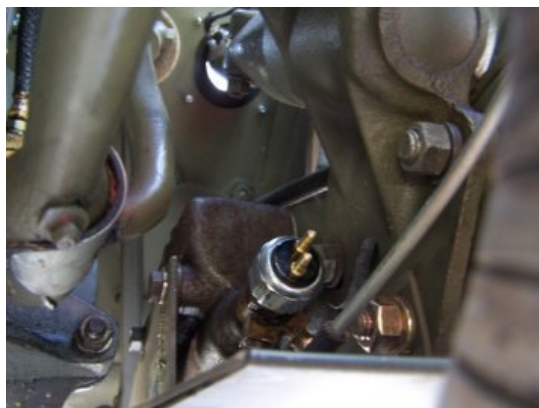
With the old brake light switch off, I want to clean around the area and inspect as best I can. I will use a LED pen light to snoop around and look for any issues.
